Manhole Inspection Summary

Manhole # S15C__016MH

Insp Date: **11/29/07 2:27 PM**

Location Address: **2559 REAR EDMONSON**

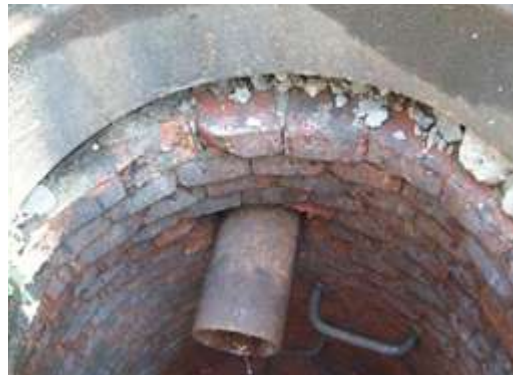
Defect 2

Condition: ☐ Sound ☒ **Cracked** ☐ Root Intrusion ☒ **Loose Brick** ☒ **Deteriorated**

cracked. loose bricks and deteriorated chimney

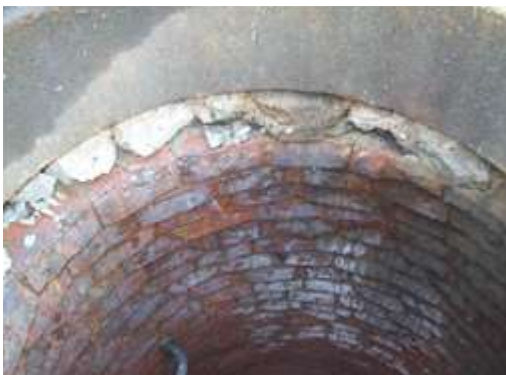
Defect 1

Condition: ☐ Sound ☐ Cracked ☐ Root Intrusion ☐ Loose Brick ☒ **Deteriorated**

deteriorated corbel

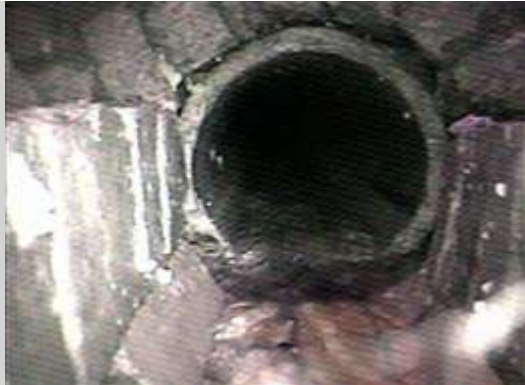
12 O'Clock Outflow

8 in. Circular Gravity Sewer
Pipe Out @ 12 O'Clock

Infiltration: **None** Pipe Seal Cond: **Cracked**

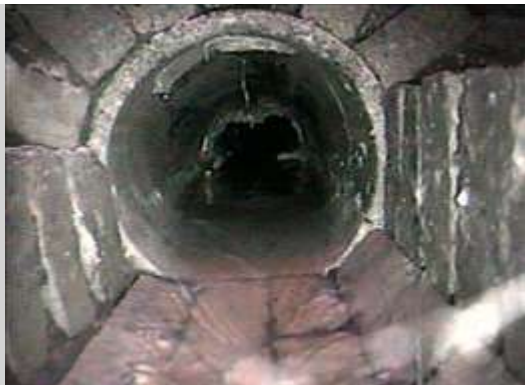
6 O'Clock Inflow

8 in. Circular Gravity Sewer
Pipe In @ 6 O'Clock

Infiltration: **None** Pipe Seal Cond: **Sound**

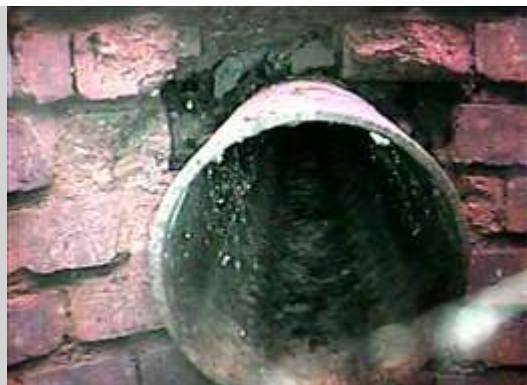
9 O'Clock Inflow

8 in. Circular Gravity Sewer
Pipe In @ 9 O'Clock

Pipe Seal Cond: **Broken**
